LEVEL 1 INSPECTION & TESTING HARRIOTT ESTATE STAGE 1 ARMSTRONG CREEK

Prepared for Bitu-Mill Pty Ltd

Report Reference: GSSW1017.1 AA

Date: 24 November 2020

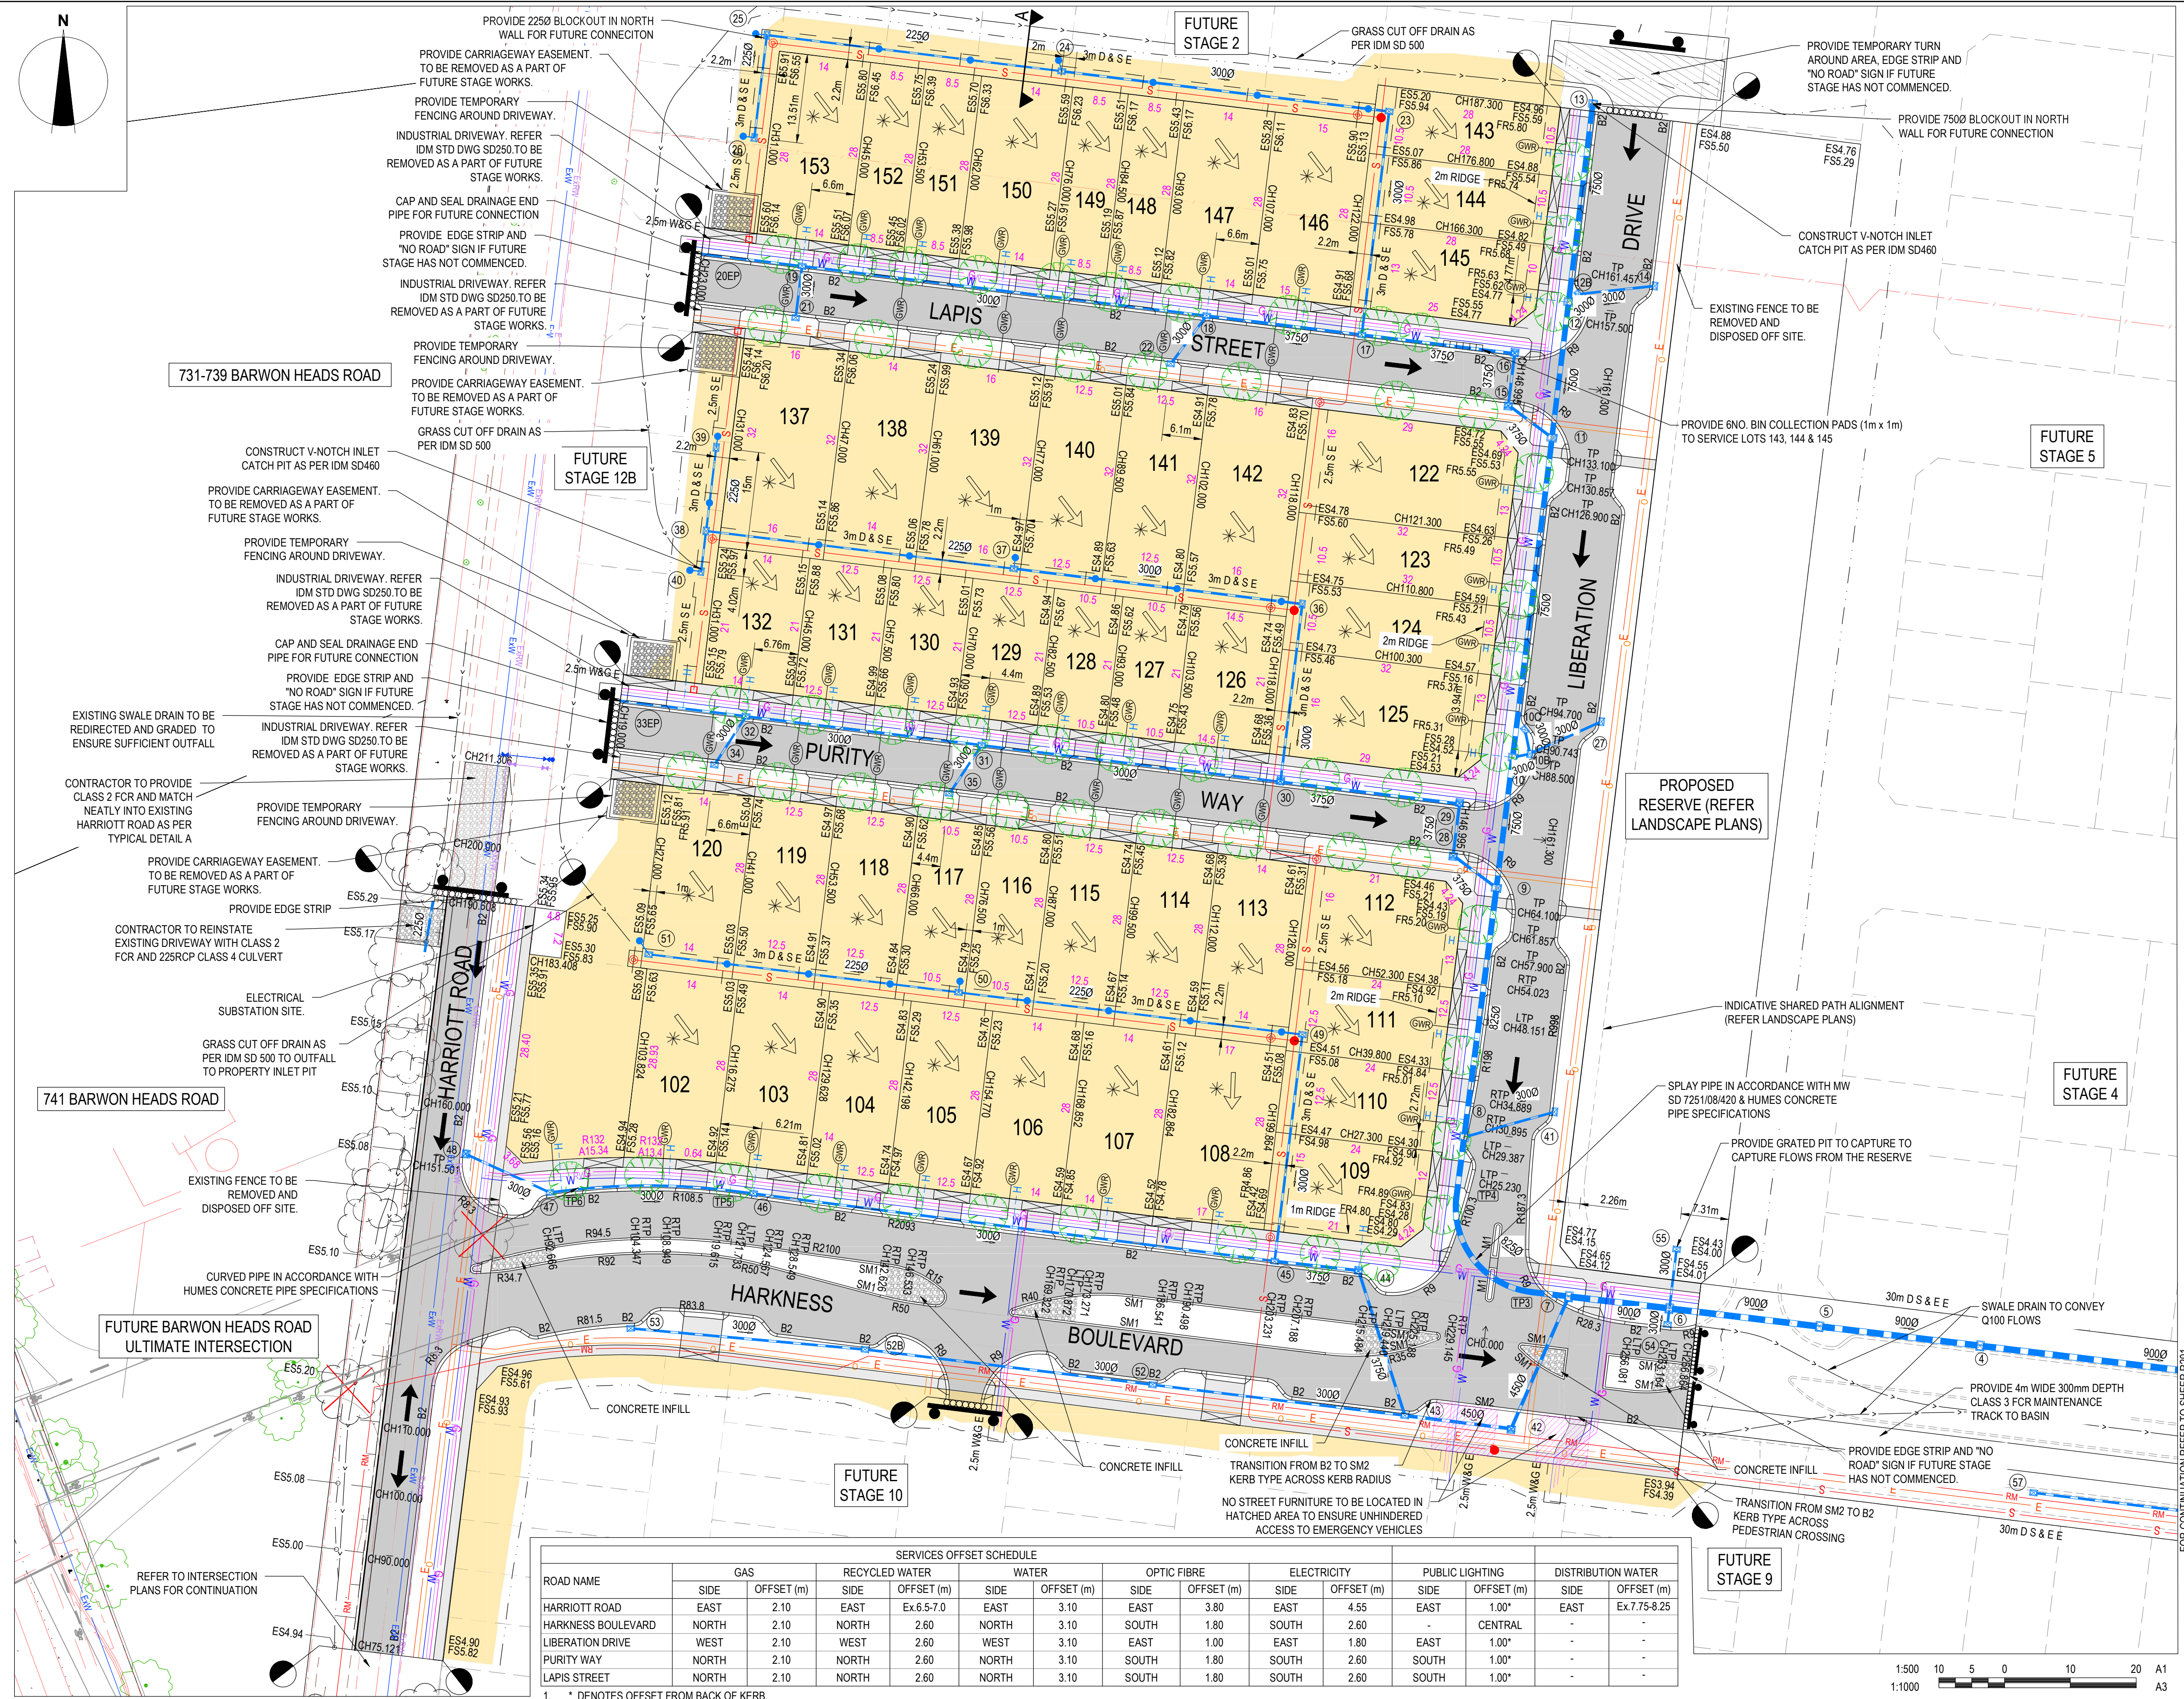
FIGURE 1

Harriott Estate - Stage 1 Layout Plan - 1

Observations were made by a Ground Science staff member that filling had been complete up to the nominated finished levels designated on Figure 1 as per confirmation provided from the contractor's site foreman. We understand that the observed final levels are the constructed finished surface levels of the controlled fill. The overall fill depths are estimated using onsite visual tactile methods and may not be a true representation of fill depths given that conditions on site may change over time. True fill depths should be obtained from the contractor's survey data.

Ground Science Staff have undertaken Level 1 Inspection and Testing services of the construction of the controlled fill in the areas designated on Figure 1. Ground Science field staff have also observed that the prepared subgrade provided an adequate base for the subsequent placement of controlled fill.

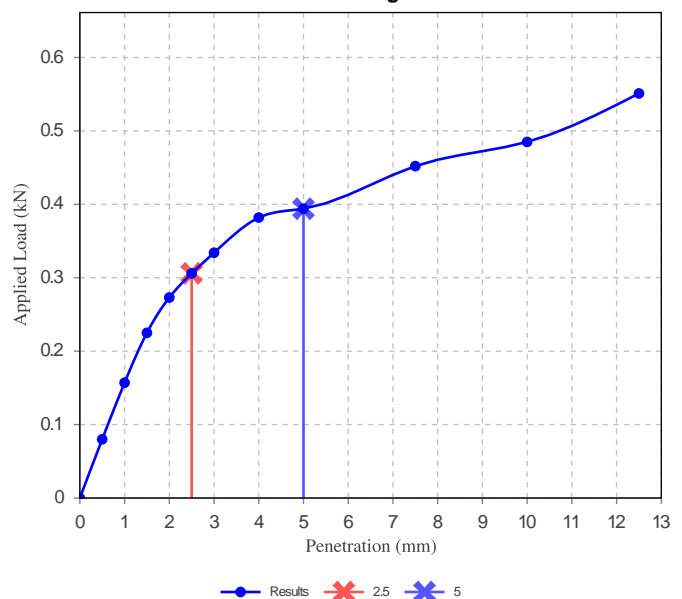
California Bearing Ratio (AS 1289 6.1.1 & 2.1.1)		Min	Max
CBR taken at	2.5 mm		
CBR %	2.5		
Method of Compactive Effort	Standard		
Method used to Determine MDD	AS 1289 5.1.1 & 2.1.1		
Method used to Determine Plasticity	Visual Assessment		
Maximum Dry Density (t/m^3)	1.61		
Optimum Moisture Content (%)	23.5		
Laboratory Density Ratio (%)	98.5		
Laboratory Moisture Ratio (%)	98.5		
Dry Density after Soaking (t/m^3)	1.52		
Field Moisture Content (%)			
Moisture Content at Placement (%)	23.1		
Moisture Content Top 30mm (%)	30.9		
Moisture Content Rest of Sample (%)	23.9		
Mass Surcharge (kg)	4.5		
Soaking Period (days)	4		
Curing Hours	171.6		
Swell (%)	3.5		
Oversize Material (mm)	19		
Oversize Material Included	Excluded		
Oversize Material (%)	0		
Sample remoulded as per Vic Roads Code of Practice RC 500.16

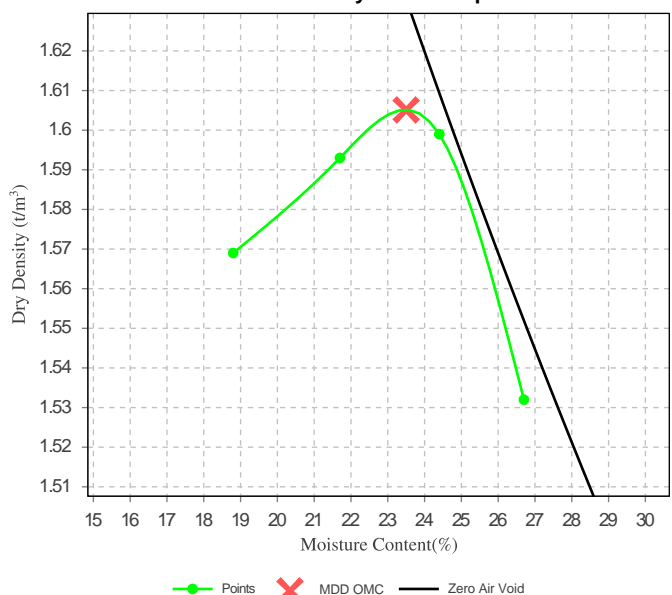
Moisture Density Relationship

Dry Density - Moisture Relationship (AS 1289 5.1.1 & 2.1.1)	
Mould Type	1 LITRE MOULD A
Compaction	Standard
Maximum Dry Density (t/m^3)	1.61
Optimum Moisture Content (%)	23.5
Oversize Sieve (mm)	19
Oversize Material Wet (%)	0
Method used to Determine Plasticity	Visual Assessment
Curing Hours	120.5

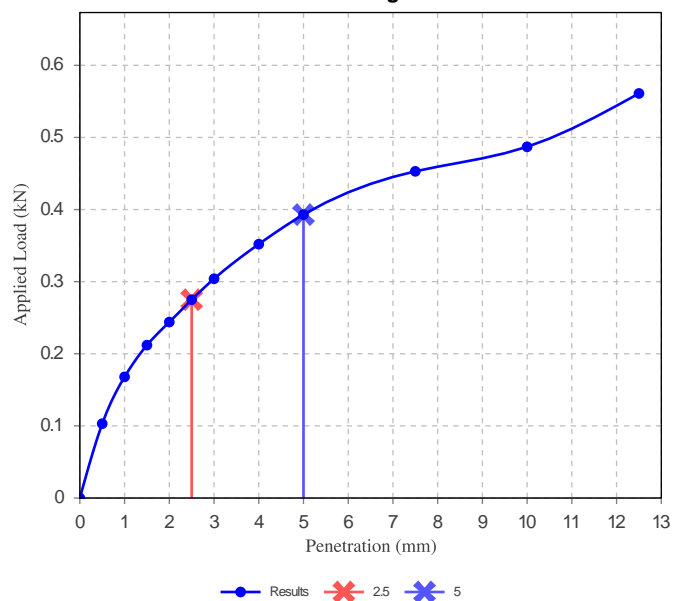
California Bearing Ratio (AS 1289 6.1.1 & 2.1.1)		Min	Max
CBR taken at	2.5 mm		
CBR %	2.0		
Method of Compactive Effort	Standard		
Method used to Determine MDD	AS 1289 5.1.1 & 2.1.1		
Method used to Determine Plasticity	Visual Assessment		
Maximum Dry Density (t/m^3)	1.53		
Optimum Moisture Content (%)	24.5		
Laboratory Density Ratio (%)	97.5		
Laboratory Moisture Ratio (%)	102.5		
Dry Density after Soaking (t/m^3)	1.44		
Field Moisture Content (%)			
Moisture Content at Placement (%)	25.0		
Moisture Content Top 30mm (%)	36.9		
Moisture Content Rest of Sample (%)	26.5		
Mass Surcharge (kg)	4.5		
Soaking Period (days)	4		
Curing Hours	170.9		
Swell (%)	3.5		
Oversize Material (mm)	19		
Oversize Material Included	Excluded		
Oversize Material (%)	0		
Sample remoulded as per Vic Roads Code of Practice RC 500.16

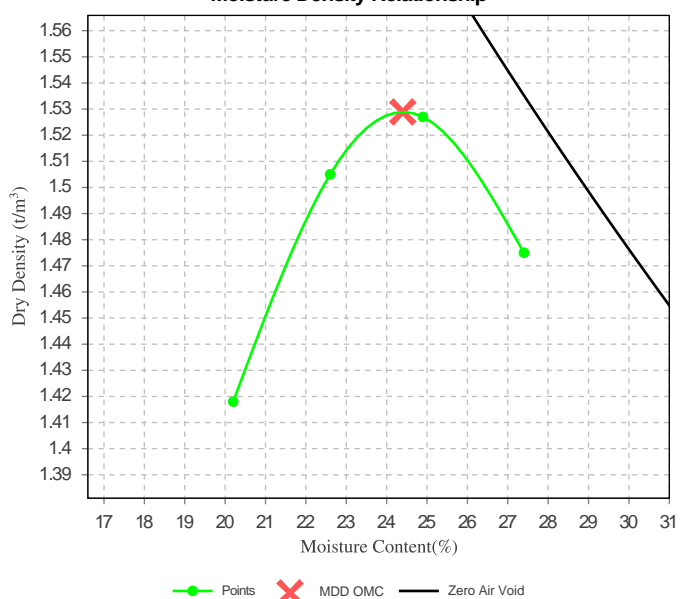
Moisture Density Relationship

Dry Density - Moisture Relationship (AS 1289 5.1.1 & 2.1.1)	
Mould Type	1 LITRE MOULD A
Compaction	Standard
Maximum Dry Density (t/m^3)	1.53
Optimum Moisture Content (%)	24.5
Oversize Sieve (mm)	19
Oversize Material Wet (%)	0
Method used to Determine Plasticity	Visual Assessment
Curing Hours	119.9
