LEVEL 1 INSPECTION & TESTING HARRIOTT ESTATE STAGE 2 ARMSTRONG CREEK

Prepared for Bitu-Mill Pty Ltd

Report Reference: GSSW1018.1 AA

Date: 8 December 2020

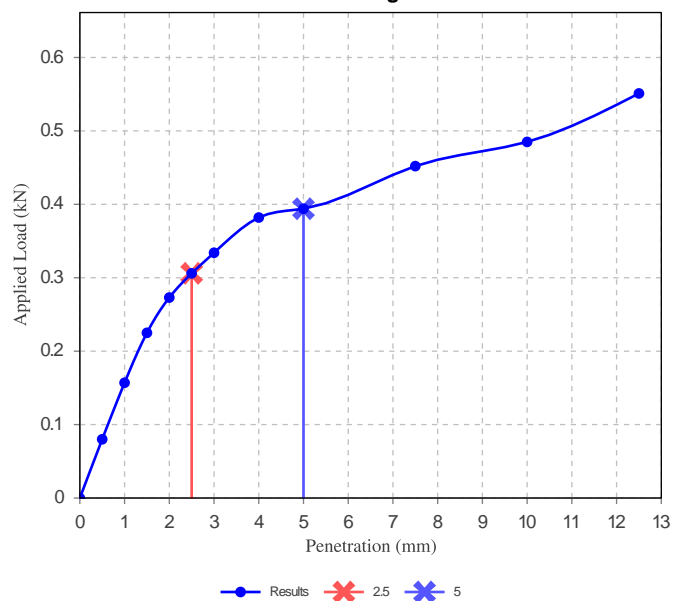
California Bearing Ratio (AS 1289 6.1.1 & 2.1.1)		Min	Max
CBR taken at	2.5 mm		
CBR %	2.5		
Method of Compactive Effort	Standard		
Method used to Determine MDD	AS 1289 5.1.1 & 2.1.1		
Method used to Determine Plasticity	Visual Assessment		
Maximum Dry Density (t/m ³)	1.61		
Optimum Moisture Content (%)	23.5		
Laboratory Density Ratio (%)	98.5		
Laboratory Moisture Ratio (%)	98.5		
Dry Density after Soaking (t/m ³)	1.52		
Field Moisture Content (%)			
Moisture Content at Placement (%)	23.1		
Moisture Content Top 30mm (%)	30.9		
Moisture Content Rest of Sample (%)	23.9		
Mass Surcharge (kg)	4.5		
Soaking Period (days)	4		
Curing Hours	171.6		
Swell (%)	3.5		
Oversize Material (mm)	19		
Oversize Material Included	Excluded		
Oversize Material (%)	0		
Sample remoulded as per Vic Roads Code of Practice RC 500.16

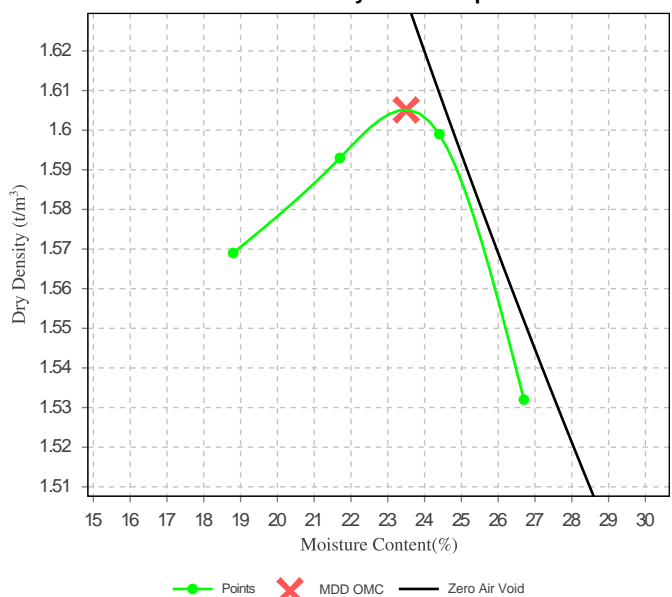
Moisture Density Relationship

Dry Density - Moisture Relationship (AS 1289 5.1.1 & 2.1.1)	
Mould Type	1 LITRE MOULD A
Compaction	Standard
Maximum Dry Density (t/m ³)	1.61
Optimum Moisture Content (%)	23.5
Oversize Sieve (mm)	19
Oversize Material Wet (%)	0
Method used to Determine Plasticity	Visual Assessment
Curing Hours	120.5
