LEVEL 1 INSPECTION & TESTING HARRIOTT ESTATE STAGE 3 ARMSTRONG CREEK

Prepared for BILD Group Pty Ltd

Report Reference: GSSW1250.1 AA

Date: 23 June 2021

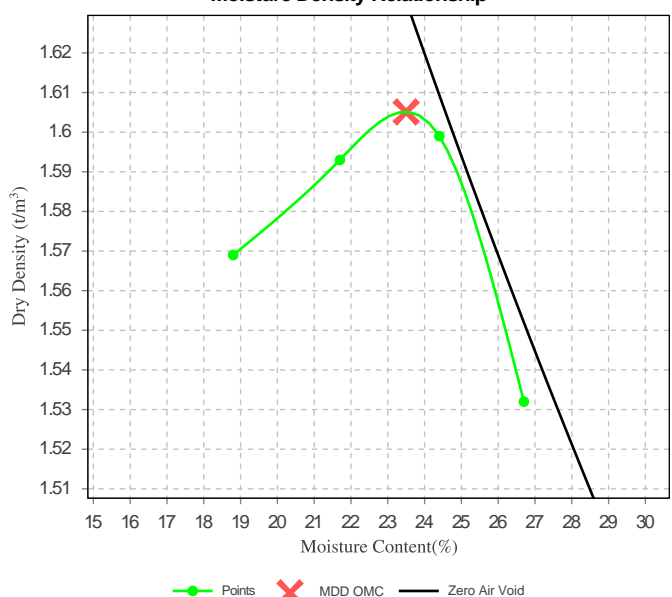
Moisture Density Relationship

Dry Density - Moisture Relationship (AS 1289 5.1.1 & 2.1.1)	
Mould Type	1 LITRE MOULD A
Compaction	Standard
Maximum Dry Density (t/m^3)	1.61
Optimum Moisture Content (%)	23.5
Oversize Sieve (mm)	19
Oversize Material Wet (%)	0
Method used to Determine Plasticity	Visual Assessment
Curing Hours	120.5

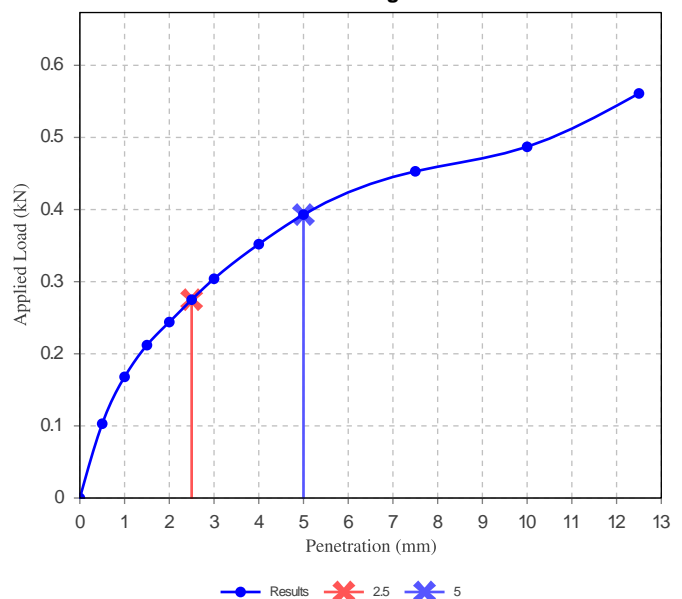
California Bearing Ratio (AS 1289 6.1.1 & 2.1.1)		Min	Max
CBR taken at	2.5 mm		
CBR %	2.0		
Method of Compactive Effort	Standard		
Method used to Determine MDD	AS 1289 5.1.1 & 2.1.1		
Method used to Determine Plasticity	Visual Assessment		
Maximum Dry Density (t/m ³)	1.53		
Optimum Moisture Content (%)	24.5		
Laboratory Density Ratio (%)	97.5		
Laboratory Moisture Ratio (%)	102.5		
Dry Density after Soaking (t/m ³)	1.44		
Field Moisture Content (%)			
Moisture Content at Placement (%)	25.0		
Moisture Content Top 30mm (%)	36.9		
Moisture Content Rest of Sample (%)	26.5		
Mass Surcharge (kg)	4.5		
Soaking Period (days)	4		
Curing Hours	170.9		
Swell (%)	3.5		
Oversize Material (mm)	19		
Oversize Material Included	Excluded		
Oversize Material (%)	0		
Sample remoulded as per Vic Roads Code of Practice RC 500.16

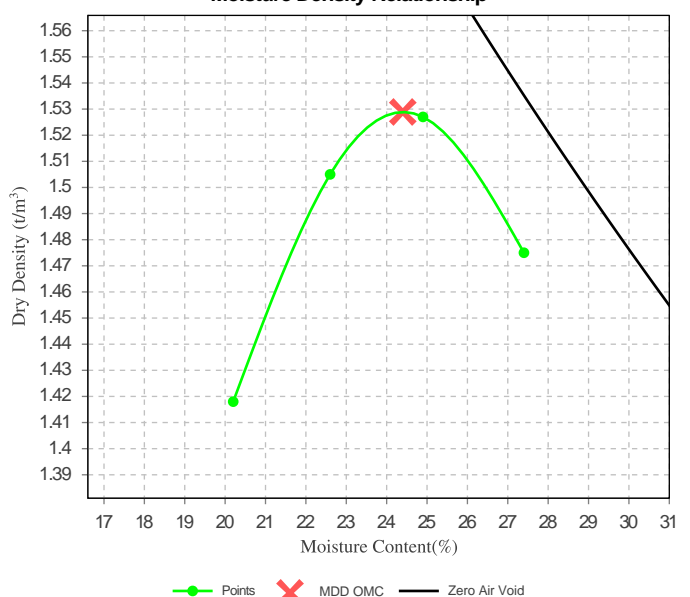
Moisture Density Relationship

Dry Density - Moisture Relationship (AS 1289 5.1.1 & 2.1.1)	
Mould Type	1 LITRE MOULD A
Compaction	Standard
Maximum Dry Density (t/m ³)	1.53
Optimum Moisture Content (%)	24.5
Oversize Sieve (mm)	19
Oversize Material Wet (%)	0
Method used to Determine Plasticity	Visual Assessment
Curing Hours	119.9
