**RE: CONTROLLED FILL CERTIFICATE  
LOT 844 HARRIOTT ESTATE, STAGE 8B, ARMSTRONG CREEK, VICTORIA**

# **LEVEL 1 INSPECTION & TESTING HARRIOTT ESTATE STAGE 8B ARMSTRONG CREEK**

Report Reference: GSSW1689.1 AA

Date: 10 November 2023

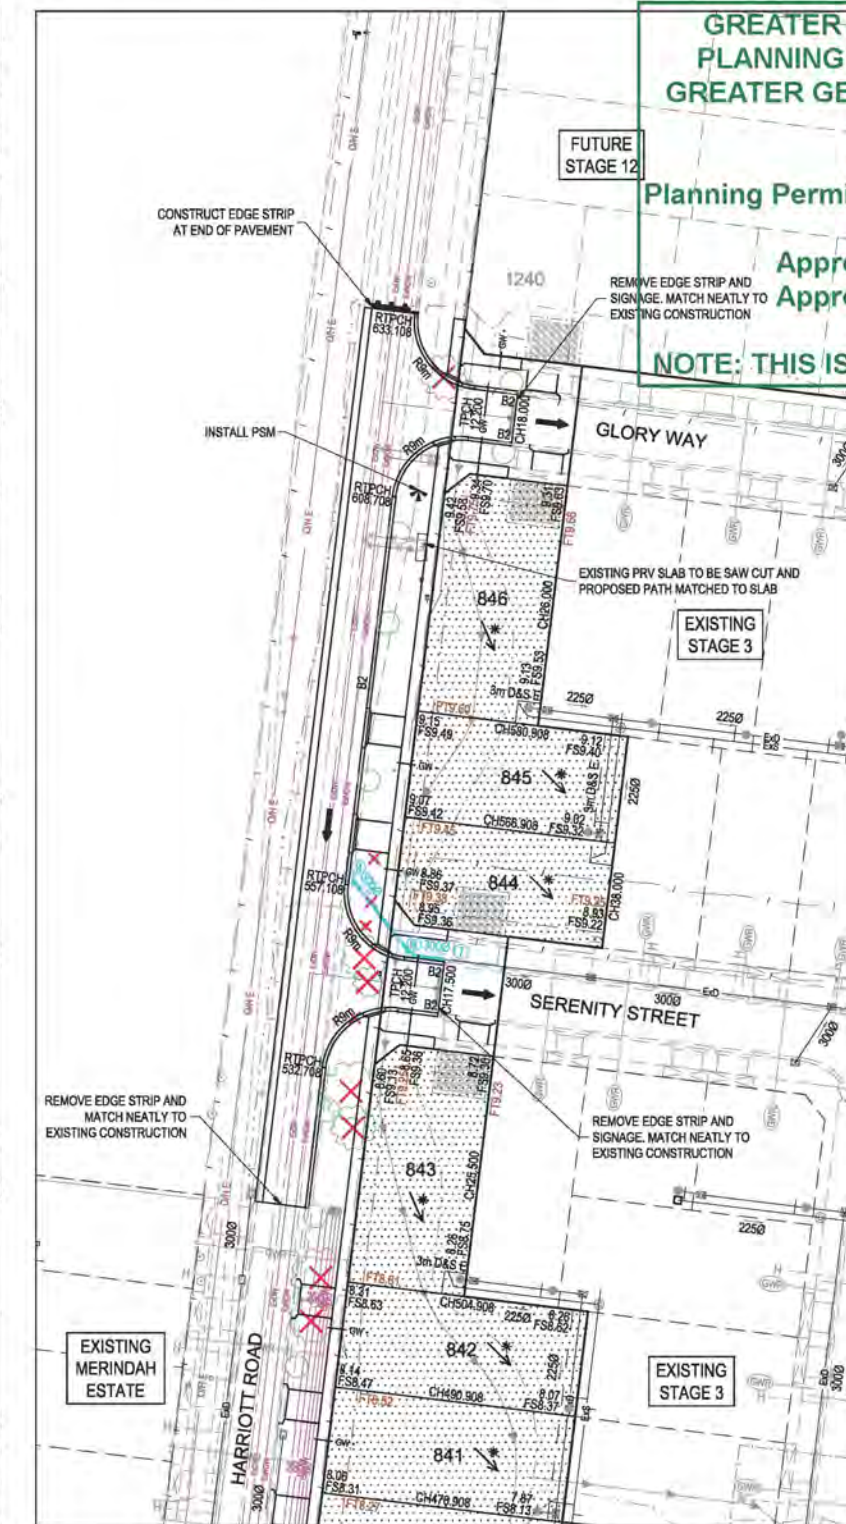
**FIGURE 1**

Harriott at Armstrong Creek Stage 8B - Layout Plan [0352-08B-R02 Rev B]

Ground Science provided Level 1 Inspection and Testing services for the construction of fill in areas requiring greater than 200mm of fill to achieve finished levels. The areas requiring Level 1 Inspection & Testing are shown on the supplied construction drawing, on Figure 1, prepared by GPR Consulting Pty Ltd (Harriott at Armstrong Creek Stage 8B - Layout Plan [0352-08B-R02 Rev B]).

Observations were made by a Ground Science staff member that filling had been complete up to the nominated finished levels designated on Figure 1 as per confirmation provided from the contractor's site foreman. We understand that the observed final levels are the constructed finished surface levels of the controlled fill. The overall fill depths are estimated using onsite visual tactile methods and may not be a true representation of fill depths given that conditions on site may change over time. True fill depths should be obtained from the contractor's survey data.

Ground Science Staff have undertaken Level 1 Inspection and Testing services of the construction of the controlled fill in the areas designated on Figure 1. Ground Science field staff have also observed that the prepared subgrade provided an adequate base for the subsequent placement of controlled fill.
