LEVEL 1 INSPECTION & TESTING HARRIOTT ESTATE STAGE 5 ARMSTRONG CREEK

Prepared for BILD Group Pty Ltd

Report Reference: GSSW1546.1 AA

Date: 16 June 2022

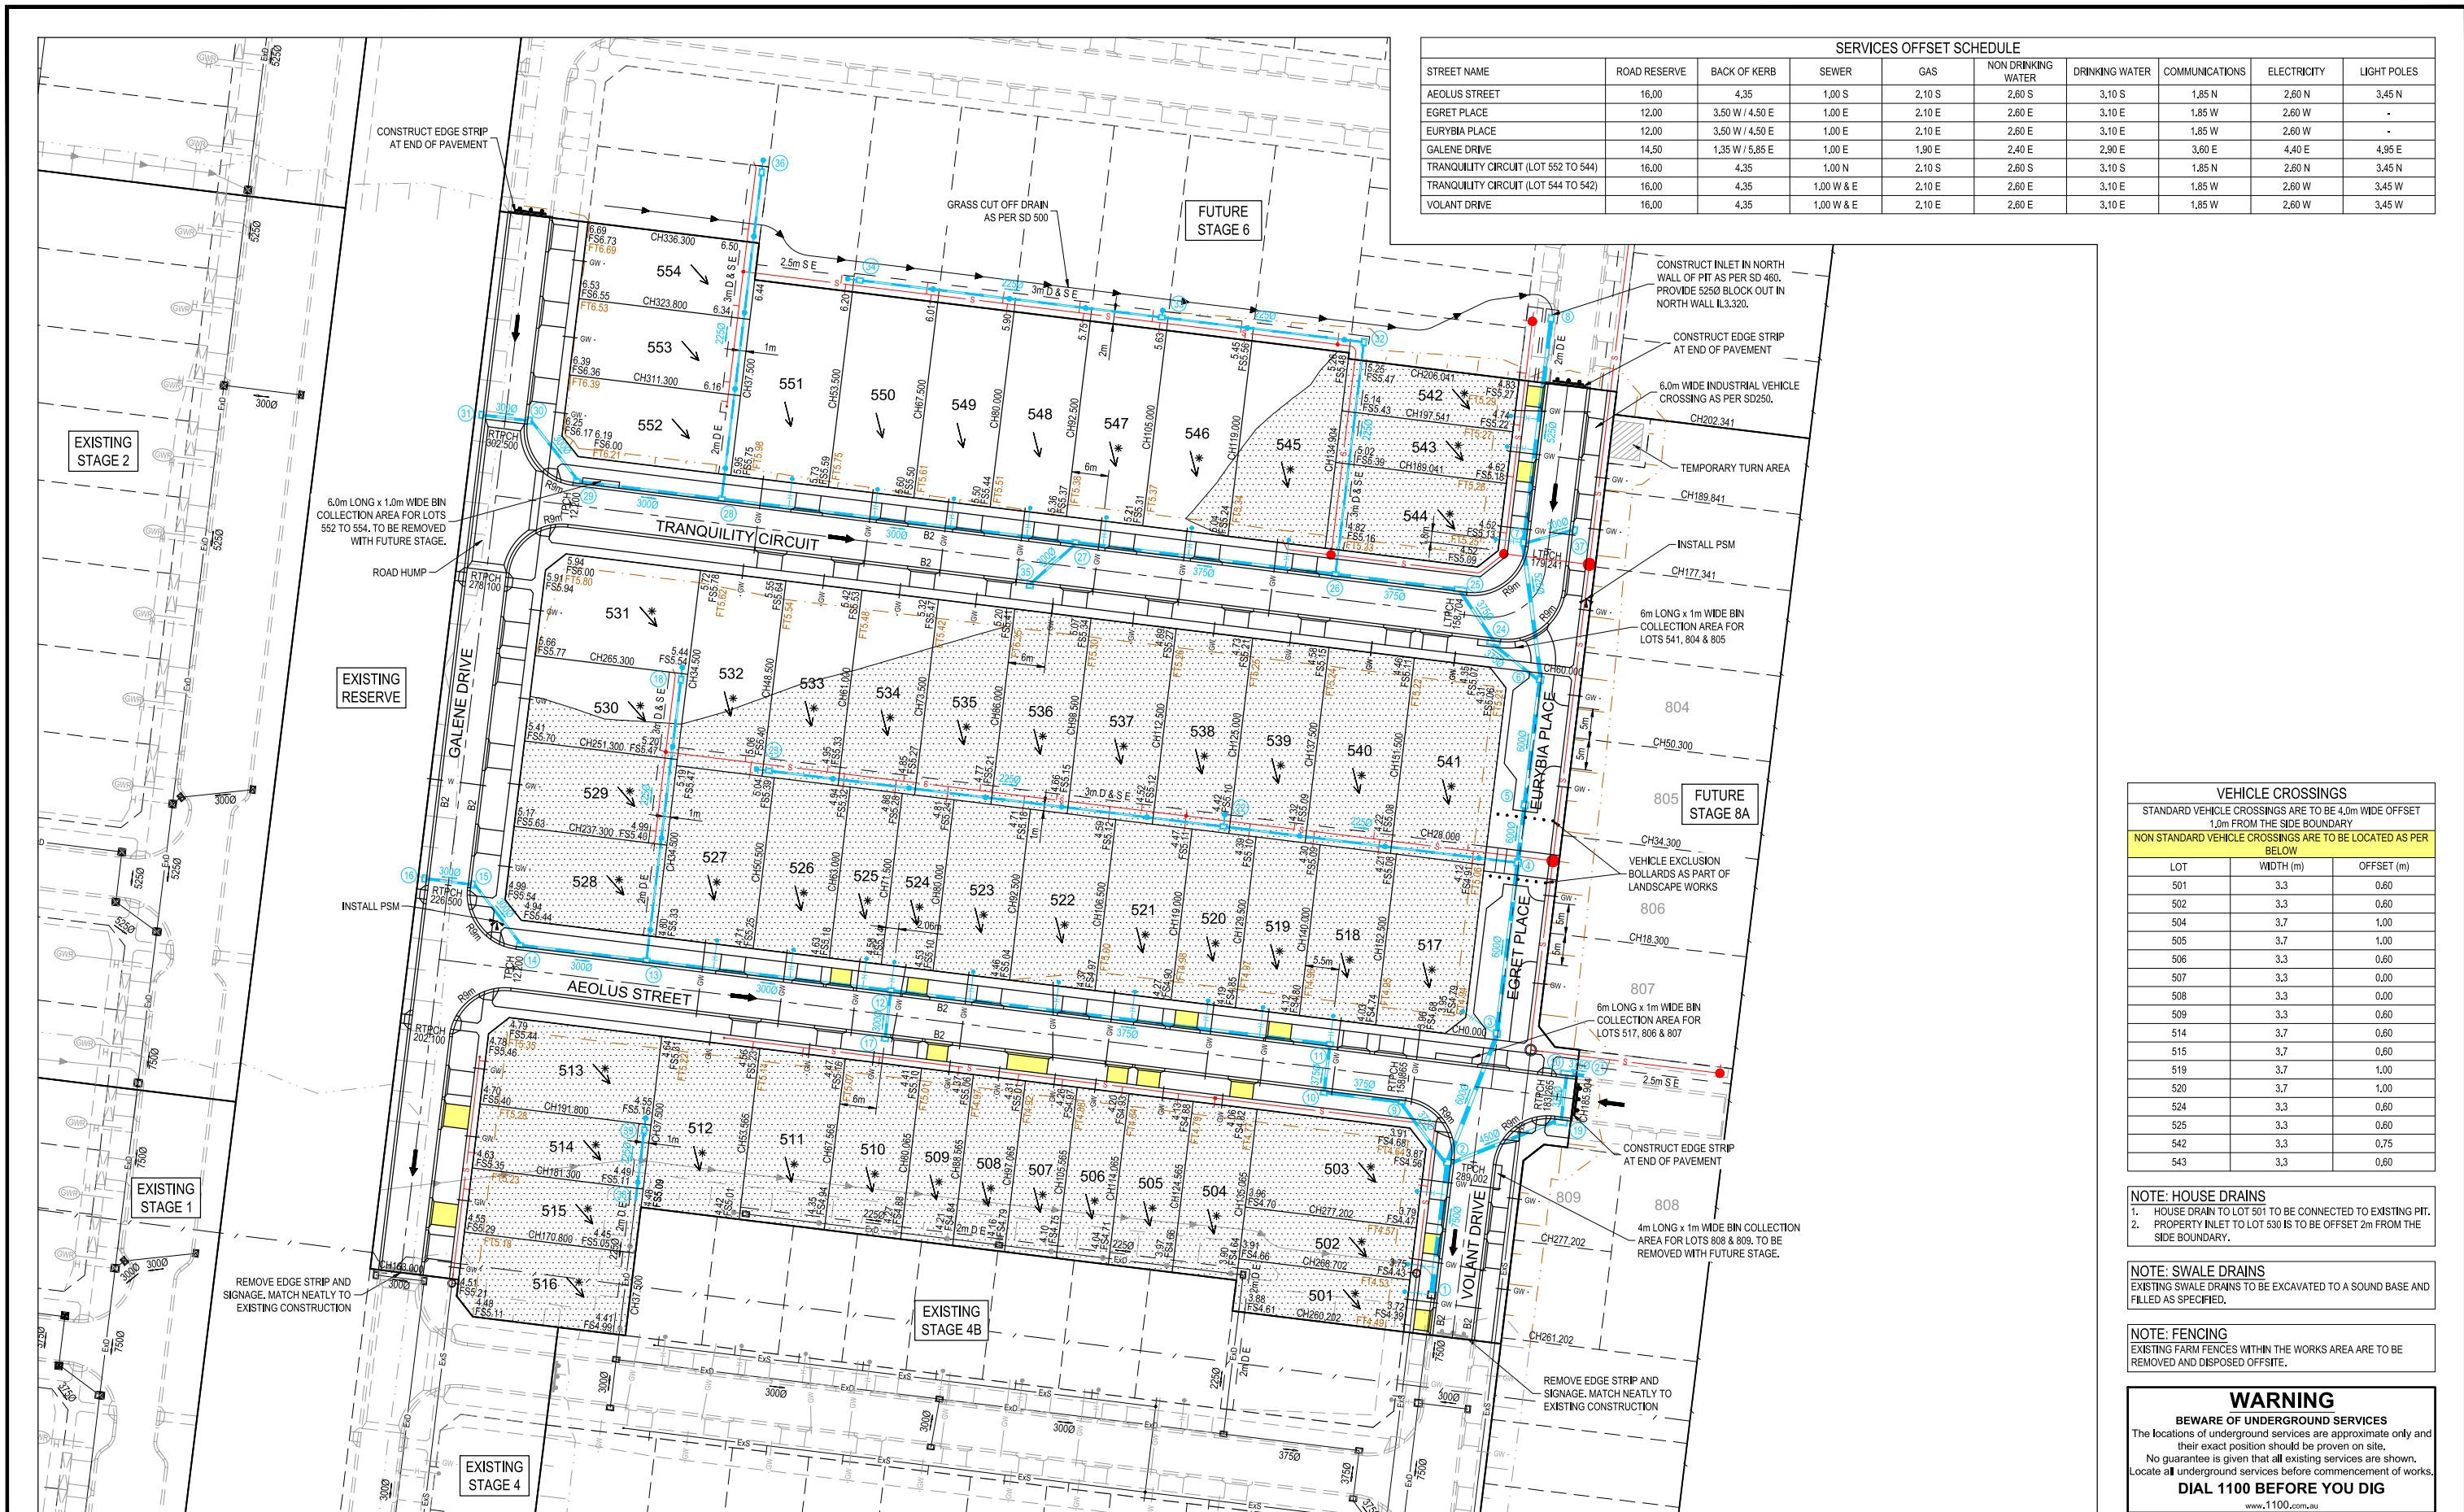
FIGURE 1

Harriott at Armstrong Creek Stage 5 - Layout Plan [0352-05-R02 Rev B]

Ground Science provided Level 1 Inspection and Testing services for the construction of fill in areas requiring greater than 200mm of fill to achieve finished levels. The areas requiring Level 1 Inspection & Testing are shown on the supplied construction drawing, on Figure 1, prepared by GPR Consulting Pty Ltd (Harriott at Armstrong Creek Stage 5 - Layout Plan [0352-05-R02 Rev B]).

Observations were made by a Ground Science staff member that filling had been complete up to the nominated finished levels designated on Figure 1 as per confirmation provided from the contractor's site foreman. We understand that the observed final levels are the constructed finished surface levels of the controlled fill. The overall fill depths are estimated using onsite visual tactile methods and may not be a true representation of fill depths given that conditions on site may change over time. True fill depths should be obtained from the contractor's survey data.

Ground Science Staff have undertaken Level 1 Inspection and Testing services of the construction of the controlled fill in the areas designated on Figure 1. Ground Science field staff have also observed that the prepared subgrade provided an adequate base for the subsequent placement of controlled fill.

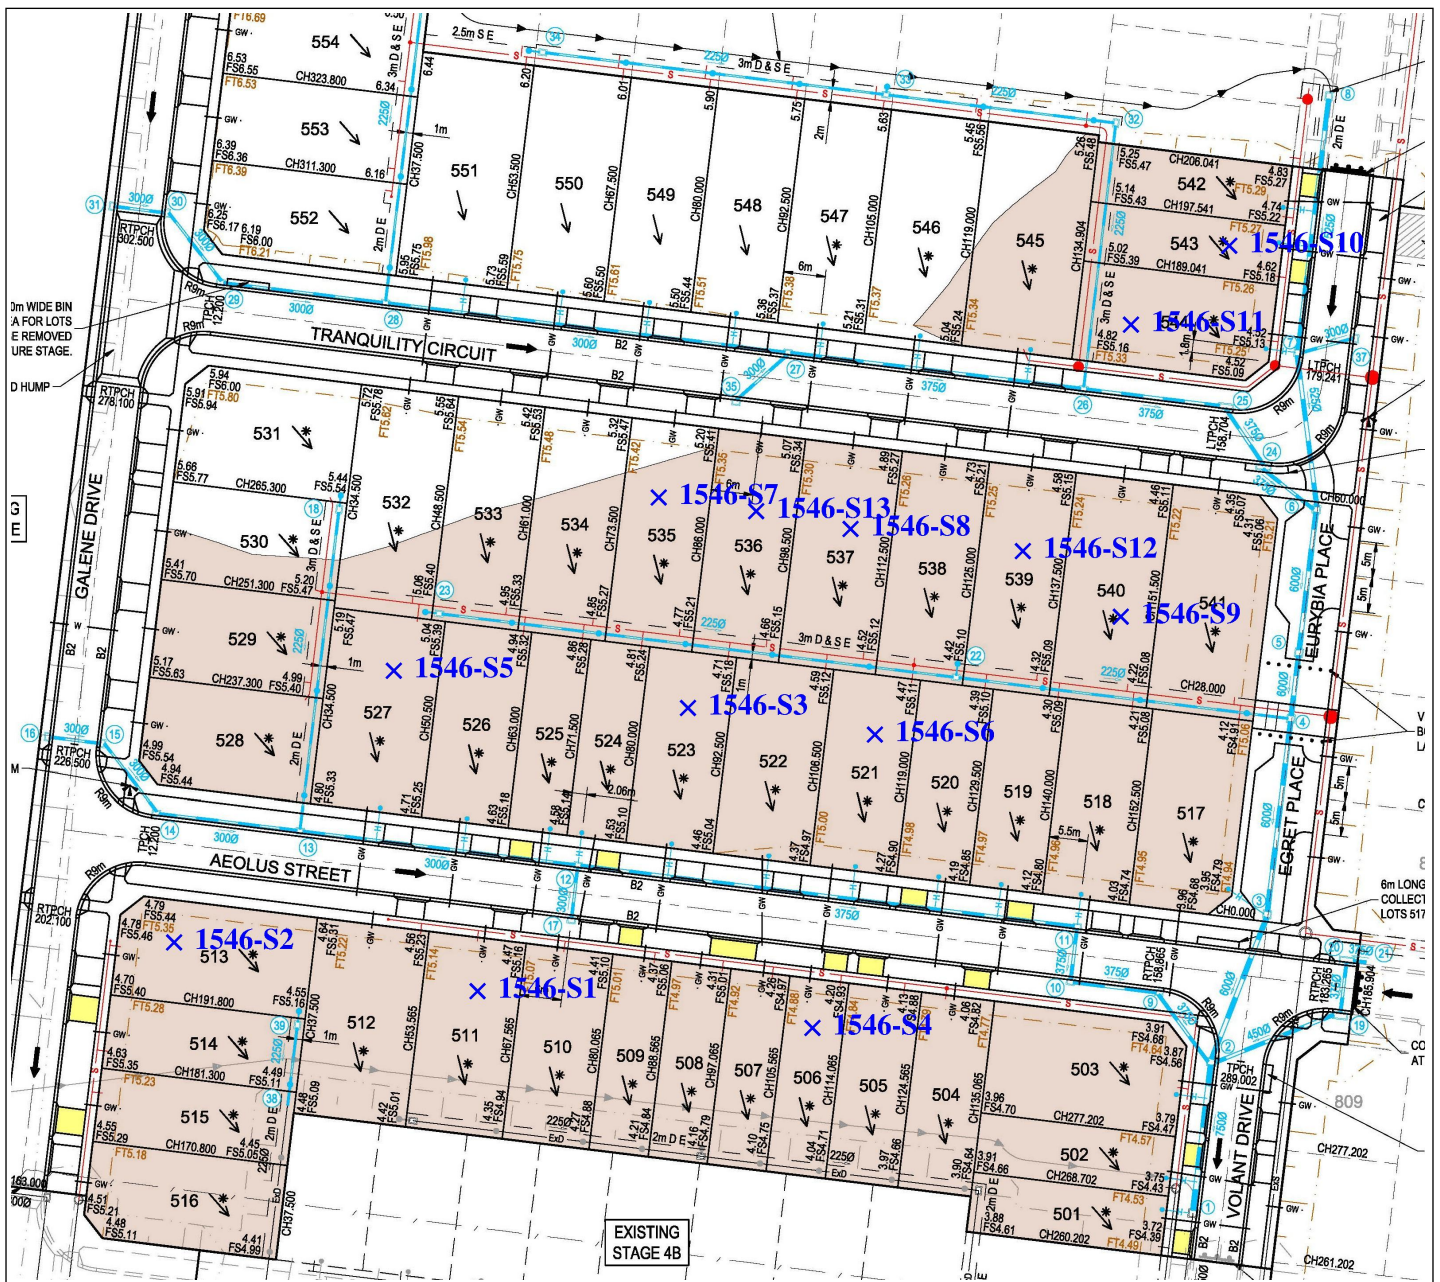
Sample Locations Plan

Lot #	Sample #	Date Sampled	Location	Location		Elevation (m)	Layer	Relative Compaction (%)	Moisture Variation (%)	Moisture Content (%)	Field Wet Density (t/m3)
516 to 504, 529 to 520	1546-S1	19/05/2022	See attached plan - Lot 511	**	**	**	Layer 1	102.5	2.5	17.2	2.06
516 to 504, 529 to 520	1546-S2	19/05/2022	See attached plan - Lot 513	**	**	**	Layer 1	103.0	2.5	17.7	2.05
516 to 504, 529 to 520	1546-S3	19/05/2022	See attached plan - Lot 523	**	**	**	Layer 1	103.0	2.5	21.2	2.05

**	1546-S4	20/05/2022	Lot 506	**	**	**	2	102.5	3.0	18.5	2.04
**	1546-S5	20/05/2022	Lot 527	**	**	**	2	101.0	2.5	18.2	2.03
**	1546-S6	20/05/2022	Lot 521	**	**	**	2	103.0	2.5	19.3	2.05
Lot 530 to 541	1546-S7	23/05/2022	Lot 535 - see attached plan	**	**	**	1	106.5	0.5	20.1	2.16
Lot 530 to 541	1546-S8	23/05/2022	Lot 537 - see attached plan	**	**	**	1	105.0	0.0	19.5	2.14
Lot 530 to 541	1546-S9	23/05/2022	Lot 540 - see attached plan	**	**	**	1	100.5	0.0	17.2	2.07
Lot 530 to 541	1546-S10	23/05/2022	Lot 543 - see attached plan	**	**	**	1	102.0	0.0	18.1	1.99
Lot 530 to 541 & 546 to 542	1546-S11	24/05/2022	Lot 544	**	**	**	2	108.0	-0.5	21.5	2.14
Lot 530 to 541 & 546 to 542	1546-S12	24/05/2022	Lot 539	**	**	**	2	106.0	0.0	22.8	2.07
Lot 530 to 541 & 546 to 542	1546-S13	24/05/2022	Lot 536	**	**	**	2	102.0	-1.0	21.6	2.06

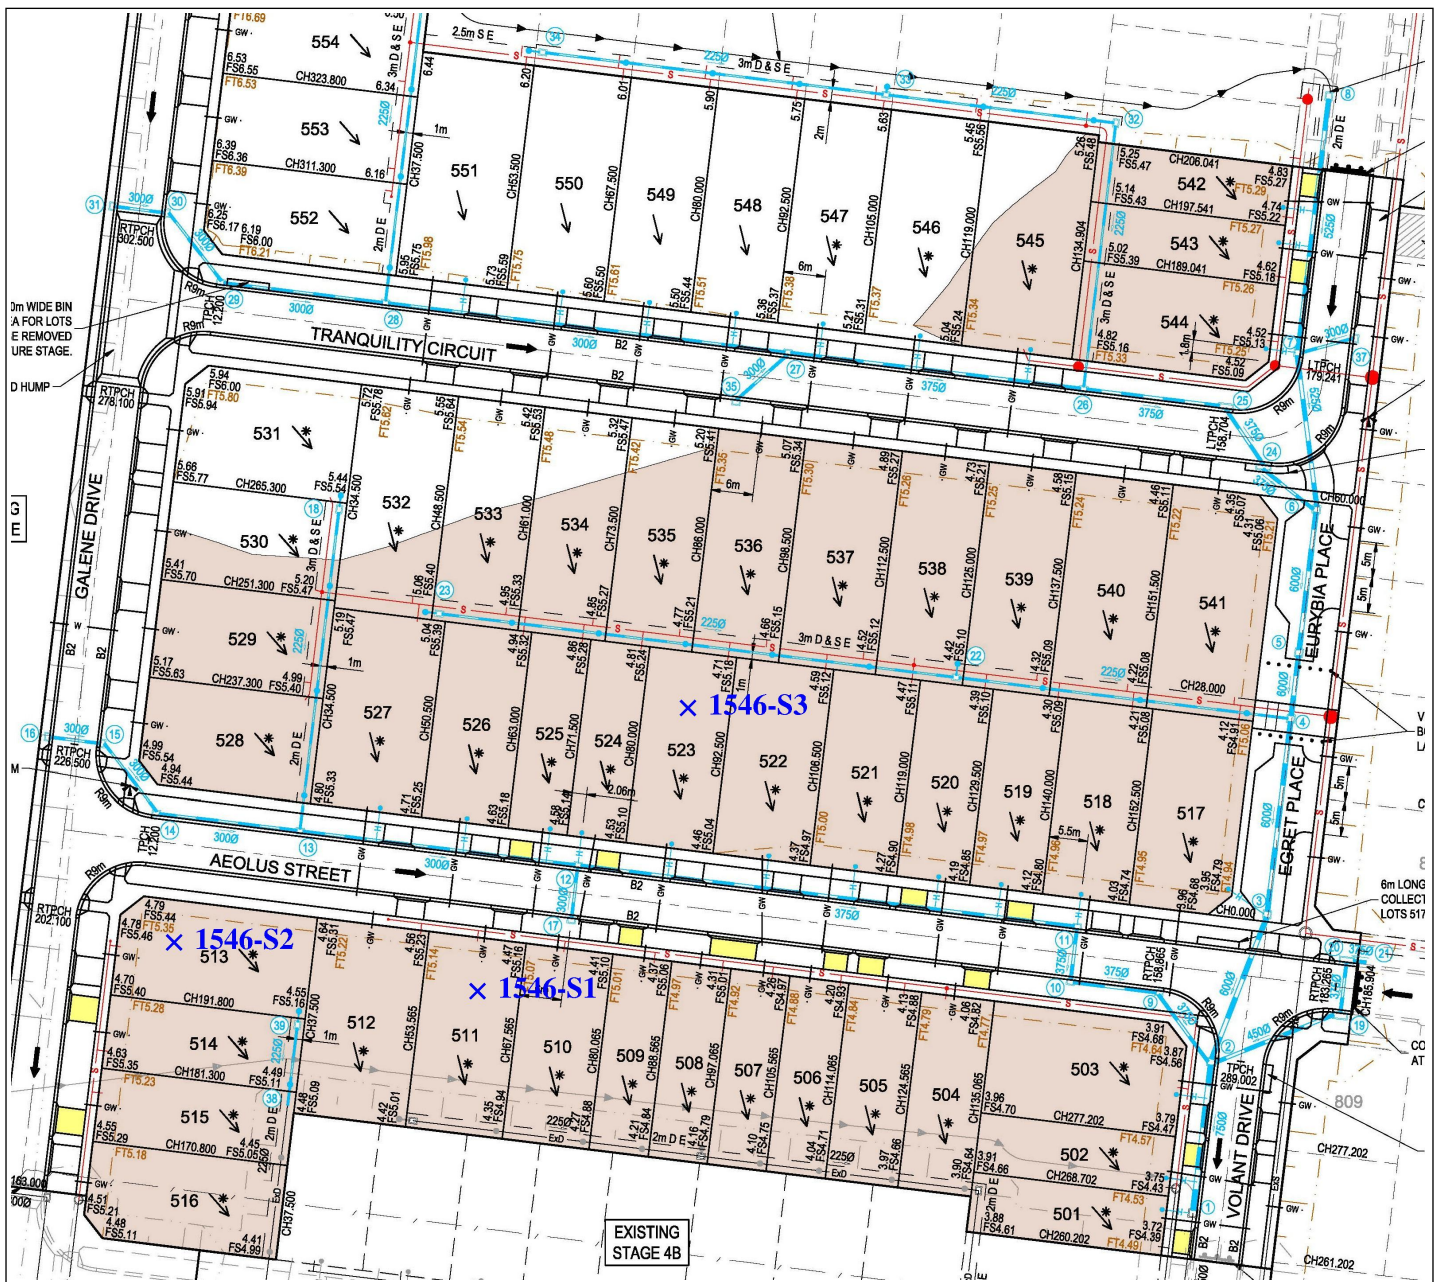
Sample Locations Plan

Compaction Control AS 1289 5.7.1 & 5.8.1 & 2.1.1			
Sample Number	1546-S1	1546-S2	1546-S3
Date Tested	19/05/2022	19/05/2022	19/05/2022
Time Tested	11:05	11:30	12:45
Test Request #/Location	See attached plan - Lot 511	See attached plan - Lot 513	See attached plan - Lot 523
Layer / Reduced Level	Layer 1	Layer 1	Layer 1
Thickness of Layer (mm)	300	300	300
Soil Description	CLAY, with sand, trace gravel, m - h plasticity	CLAY, with sand, trace gravel, m - h plasticity	CLAY, with sand, trace gravel, m - h plasticity
Test Depth (mm)	275	275	275
Sieve used to determine oversize (mm)	19.0	19.0	19.0
Percentage of Wet Oversize (%)	0	0	0
Field Wet Density (FWD) t/m ³	2.06	2.05	2.05
Field Moisture Content %	17.2	17.7	21.2
Field Dry Density (FDD) t/m ³	1.76	1.75	1.69
Peak Converted Wet Density t/m ³	2.01	1.99	2.00
Adjusted Peak Converted Wet Density t/m ³	**	**	**
Moisture Variation (Wv) %	2.5	2.5	2.5
Adjusted Moisture Variation %	**	**	**

Hilf Density Ratio (%)	102.5	103.0	103.0
Compaction Method	Standard	Standard	Standard
Report Remarks	**	**	**

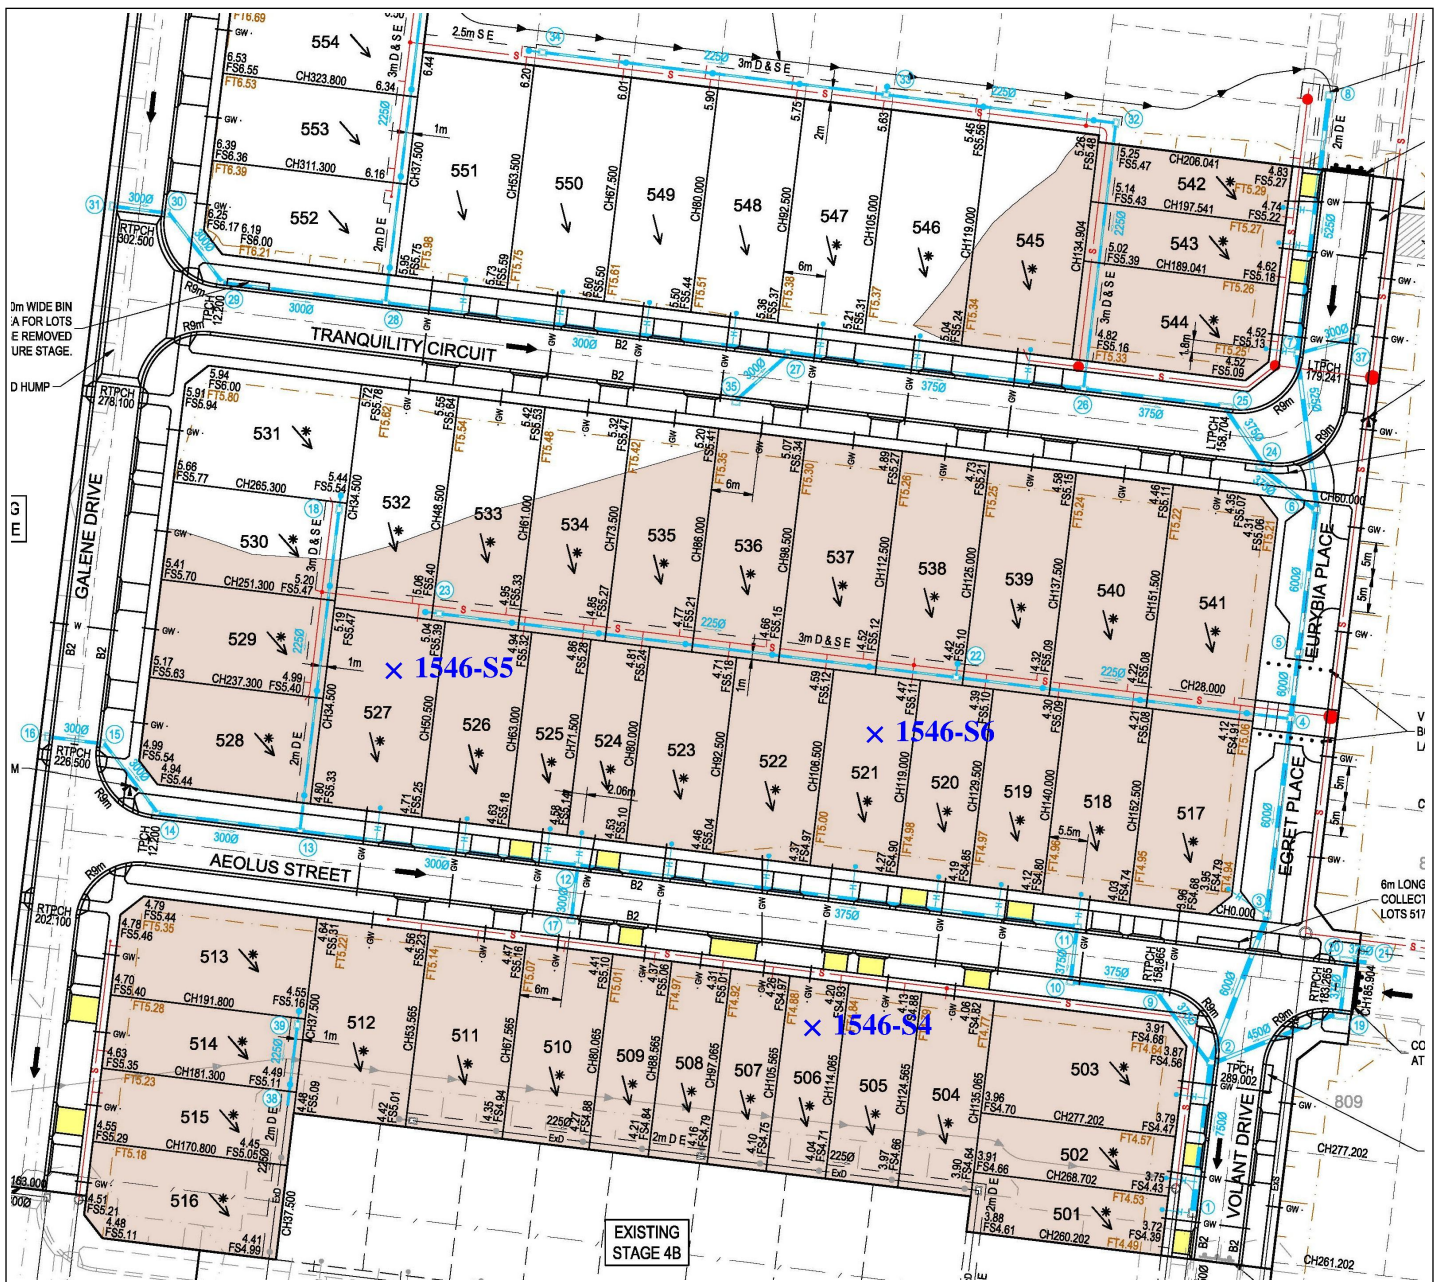
Sample Locations Plan

Sample Number	1546-S4	1546-S5	1546-S6
Date Tested	20/05/2022	20/05/2022	20/05/2022
Time Tested	11:32	15:00	15:46
Test Request #/Location	Lot 506	Lot 527	Lot 521
Layer / Reduced Level	2	2	2
Thickness of Layer (mm)	300	300	300
Soil Description	CLAY, with sand, trace gravel, m-h plasticity	CLAY, with sand, trace gravel, m-h plasticity	CLAY, with sand, trace gravel, m-h plasticity
Test Depth (mm)	275	275	275
Sieve used to determine oversize (mm)	19.0	19.0	19.0
Percentage of Wet Oversize (%)	0	0	0
Field Wet Density (FWD) t/m ³	2.04	2.03	2.05
Field Moisture Content %	18.5	18.2	19.3
Field Dry Density (FDD) t/m ³	1.72	1.72	1.72
Peak Converted Wet Density t/m ³	1.99	2.01	1.99
Adjusted Peak Converted Wet Density t/m ³	**	**	**
Moisture Variation (Wv) %	3.0	2.5	2.5
Adjusted Moisture Variation %	**	**	**
Hilf Density Ratio (%)	102.5	101.0	103.0
Compaction Method	Standard	Standard	Standard
Report Remarks	**	**	**

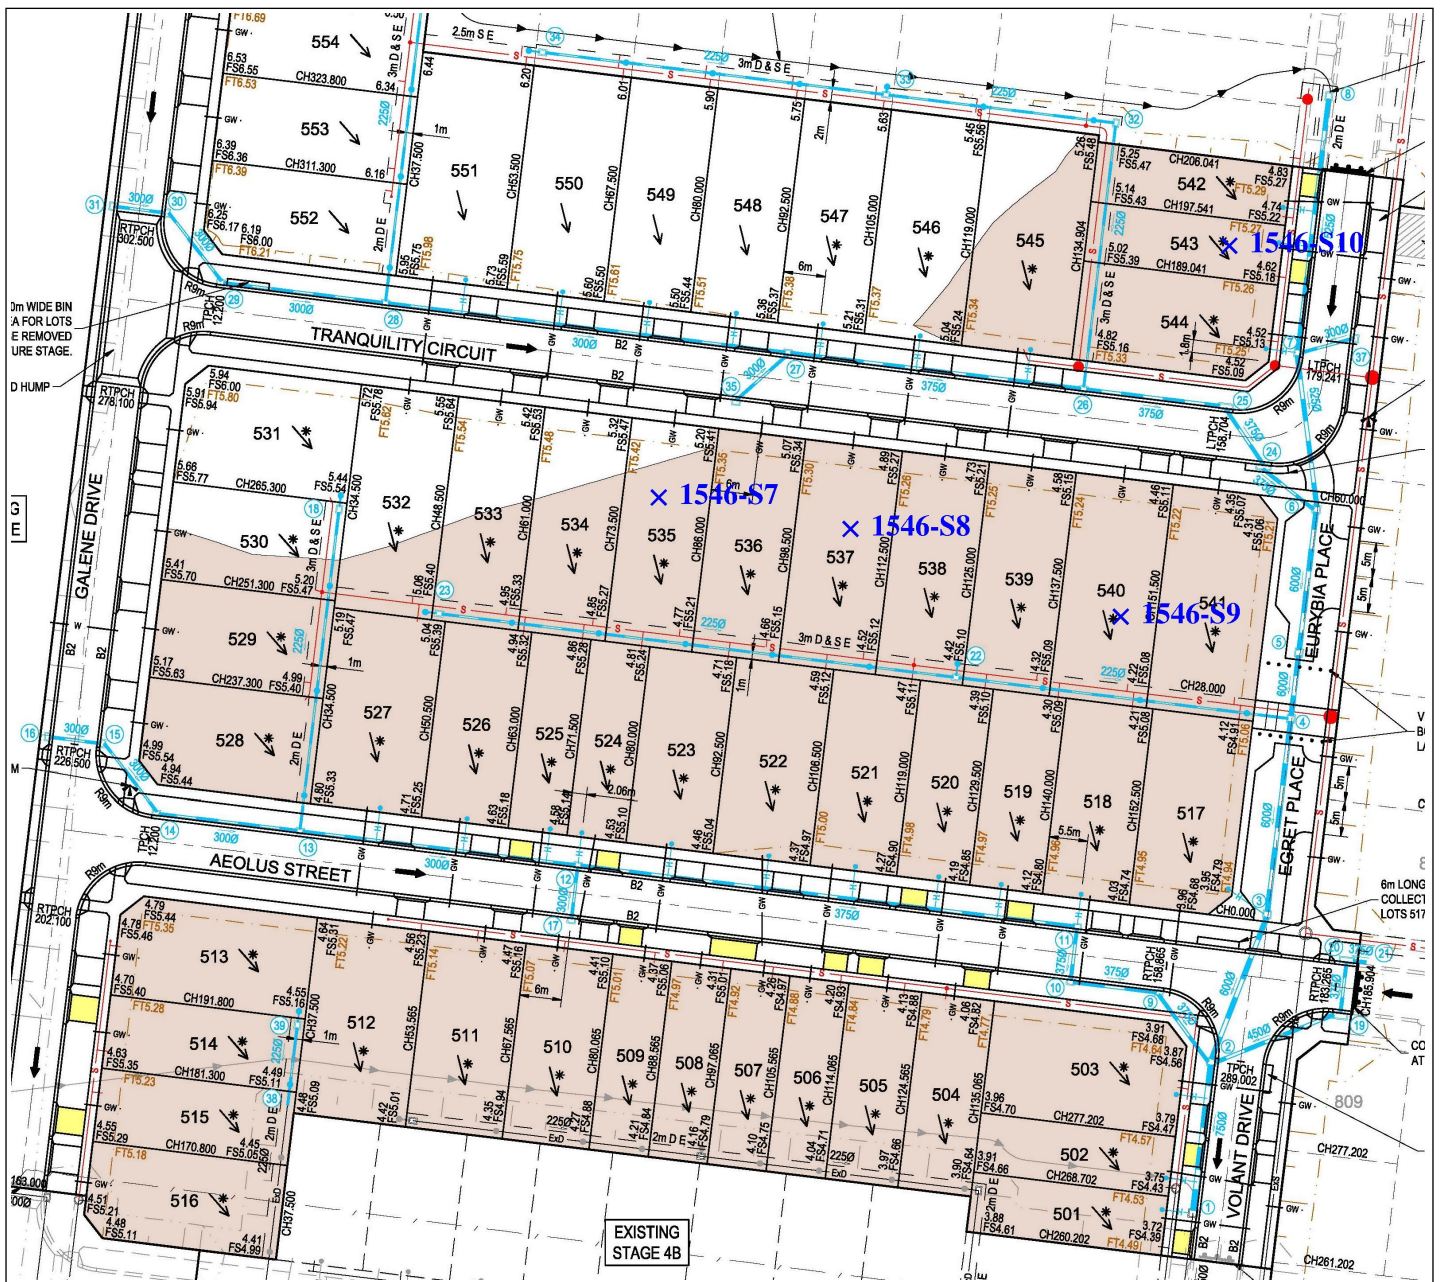
Sample Locations Plan

Sample Number	1546-S7	1546-S8	1546-S9	1546-S10
Date Tested	23/05/2022	23/05/2022	23/05/2022	23/05/2022
Time Tested	12:05	12:30	13:03	15:34
Test Request #/Location	Lot 535 - see attached plan	Lot 537 - see attached plan	Lot 540 - see attached plan	Lot 543 - see attached plan
Layer / Reduced Level	1	1	1	1
Thickness of Layer (mm)	300	300	300	300
Soil Description	CLAY, with sand, trace gravel, high plasticity	CLAY, with sand, trace gravel, high plasticity	CLAY, with sand, trace gravel, high plasticity	CLAY, with sand, trace gravel, high plasticity
Test Depth (mm)	275	275	275	275
Sieve used to determine oversize (mm)	19.0	19.0	19.0	19.0
Percentage of Wet Oversize (%)	0	0	0	0
Field Wet Density (FWD) t/m ³	2.16	2.14	2.07	1.99
Field Moisture Content %	20.1	19.5	17.2	18.1
Field Dry Density (FDD) t/m ³	1.79	1.79	1.76	1.69
Peak Converted Wet Density t/m ³	2.03	2.04	2.05	1.95
Adjusted Peak Converted Wet Density t/m ³	**	**	**	**

Moisture Variation (Wv) %	0.5	0.0	0.0	0.0
Adjusted Moisture Variation %	**	**	**	**
Hilf Density Ratio (%)	106.5	105.0	100.5	102.0
Compaction Method	Standard	Standard	Standard	Standard
Report Remarks	**	**	**	**

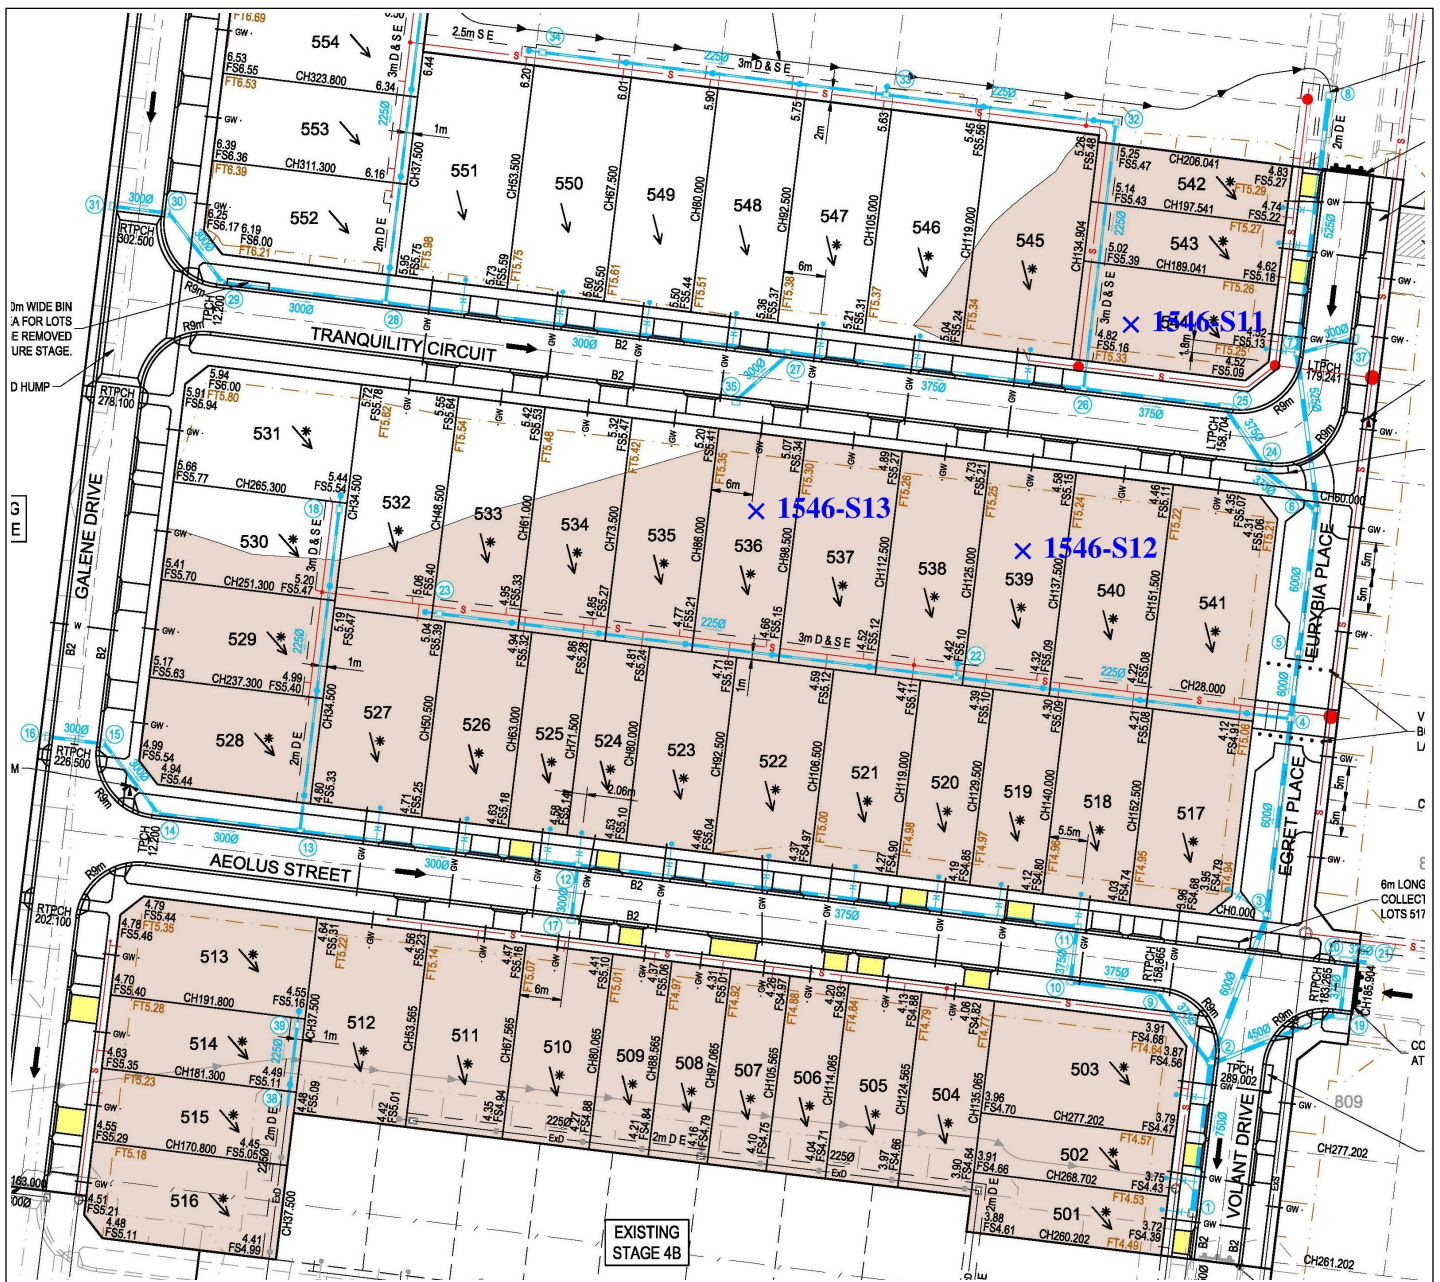
Sample Locations Plan

Sample Number	1546-S11	1546-S12	1546-S13
Date Tested	24/05/2022	24/05/2022	24/05/2022
Time Tested	11:55	15:30	15:51
Test Request #/Location	Lot 544	Lot 539	Lot 536
Layer / Reduced Level	2	2	2
Thickness of Layer (mm)	300	300	300
Soil Description	CLAY, with sand, trace gravel, high plasticity	CLAY, with sand, trace gravel, high plasticity	CLAY, with sand, trace gravel, high plasticity
Test Depth (mm)	275	275	275
Sieve used to determine oversize (mm)	19.0	19.0	19.0
Percentage of Wet Oversize (%)	0	0	0
Field Wet Density (FWD) t/m ³	2.14	2.07	2.06
Field Moisture Content %	21.5	22.8	21.6
Field Dry Density (FDD) t/m ³	1.76	1.69	1.70
Peak Converted Wet Density t/m ³	1.99	1.96	2.02
Adjusted Peak Converted Wet Density t/m ³	**	**	**
Moisture Variation (Wv) %	-0.5	0.0	-1.0
Adjusted Moisture Variation %	**	**	**
Hilf Density Ratio (%)	108.0	106.0	102.0
Compaction Method	Standard	Standard	Standard
Report Remarks	**	**	**
