LEVEL 1 INSPECTION & TESTING HARRIOTT ESTATE STAGE 8A ARMSTRONG CREEK

Prepared for BILD Group Pty Ltd

Report Reference: GSSW1548.1 AA

Date: 12 August 2022

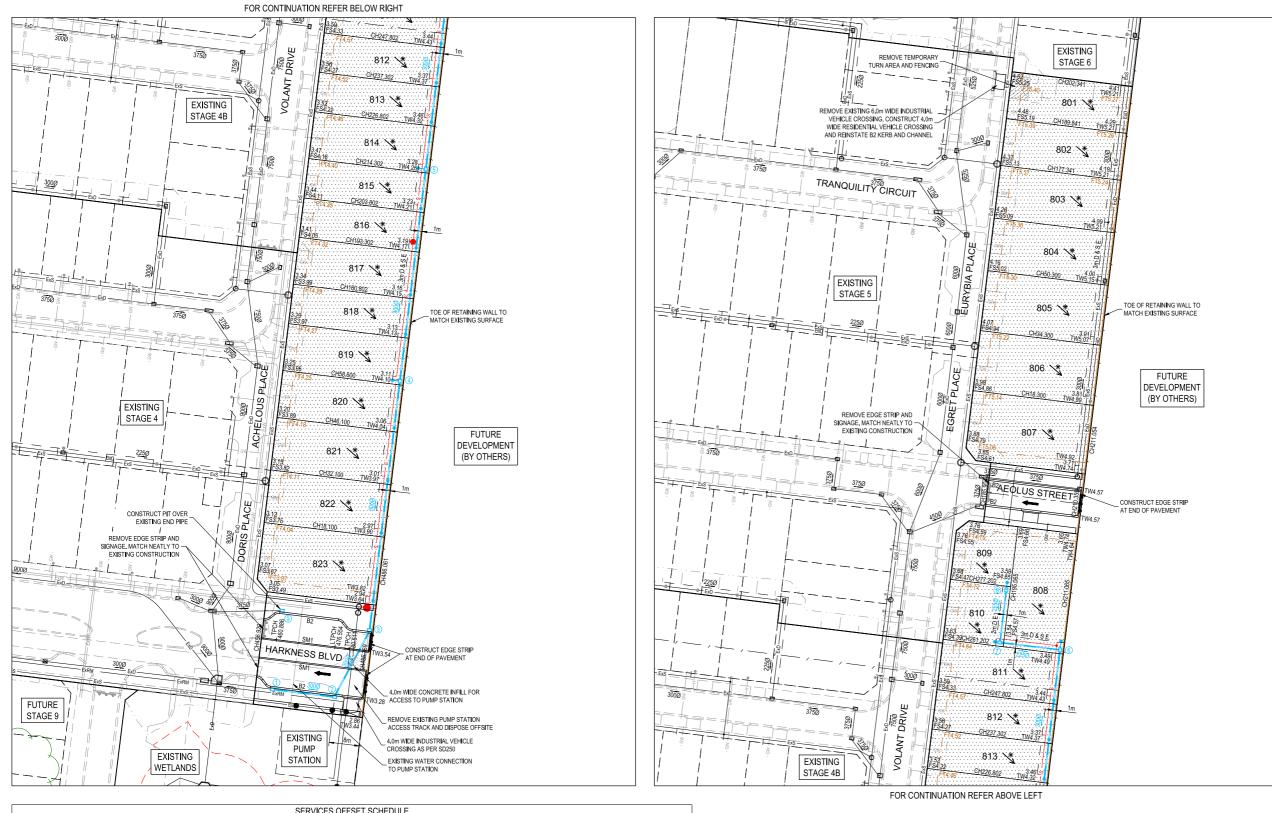
FIGURE 1

Ground Science provided Level 1 Inspection and Testing services for the construction of fill in areas requiring greater than 200mm of fill to achieve finished levels. The areas requiring Level 1 Inspection & Testing are shown on the supplied construction drawing, on Figure 1, prepared by GPR Consulting Pty Ltd (Harriott at Armstrong Creek Stage 8A - Layout Plan [0352-08A-R02 Rev A]).

Harriott at Armstrong Creek Stage 8A - Layout Plan [0352-08A-R02 Rev A]

Observations were made by a Ground Science staff member that filling had been complete up to the nominated finished levels designated on Figure 1 as per confirmation provided from the contractor's site foreman. We understand that the observed final levels are the constructed finished surface levels of the controlled fill. The overall fill depths are estimated using onsite visual tactile methods and may not be a true representation of fill depths given that conditions on site may change over time. True fill depths should be obtained from the contractor's survey data.

Ground Science Staff have undertaken Level 1 Inspection and Testing services of the construction of the controlled fill in the areas designated on Figure 1. Ground Science field staff have also observed that the prepared subgrade provided an adequate base for the subsequent placement of controlled fill.

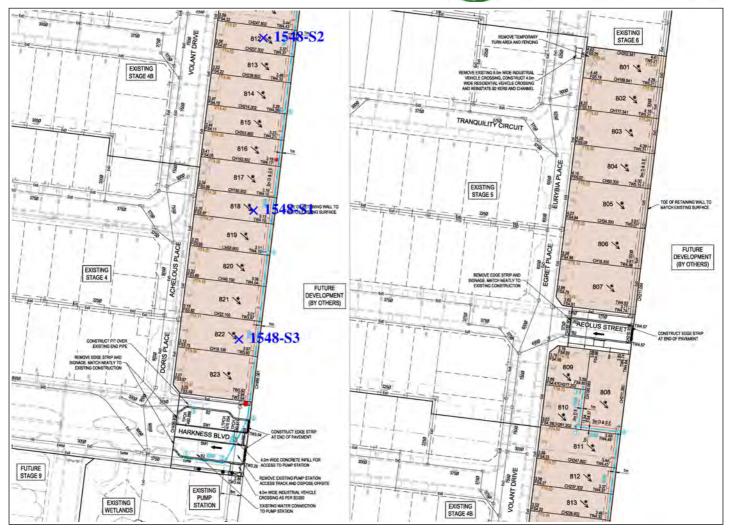
Report Number: GSSW1548-1

Compaction Control AS 1289 5.7.1 & 5.8.1 & 2.1.1							
Sample Number	1548-S1	1548-S2	1548-S3				
Date Tested	23/06/2022	23/06/2022	23/06/2022				
Time Tested	12:31	12:46	12:59				
Test Request #/Location	Lot #812	Lot #818	Lot #822				
Layer / Reduced Level	1	1	1				
Thickness of Layer (mm)	300	300	300				
Soil Description	Sandy CLAY with gravel, pale brown/orange, L-M PI	Sandy CLAY with gravel, pale brown/orange, L-M PI	Sandy CLAY with gravel, pale brown/orange, L-M PI				
Test Depth (mm)	275	275	275				
Sieve used to determine oversize (mm)	19.0	19.0	19.0				
Percentage of Wet Oversize (%)	0	0	0				
Field Wet Density (FWD) t/m ³	2.11	2.13	1.96				
Field Moisture Content %	11.6	10.4	10.9				
Field Dry Density (FDD) t/m ³	1.89	1.93	1.76				
Peak Converted Wet Density t/m ³	2.06	2.01	2.01				
Adjusted Peak Converted Wet Density t/m3	**	**	**				
Moisture Variation (Wv) %	2.0	2.0	2.5				
Adjusted Moisture Variation %	**	**	**

Hilf Density Ratio (%)	102.5	106.5	97.5				
Compaction Method	Standard	Standard	Standard				
Report Remarks	**	**	**

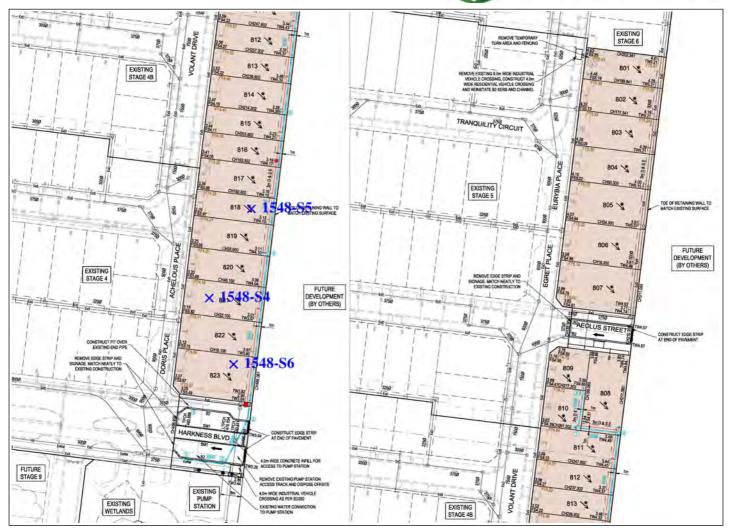
Report Number: GSSW1548-2

Compaction Control AS 1289 5.7.1 & 5.8.1 & 2.1.1							
Sample Number	1548-S4	1548-S5	1548-S6				
Date Tested	24/06/2022	24/06/2022	24/06/2022				
Time Tested	14:24	14:36	14:52				
Test Request #/Location	Lot #821	Lot #818	Lot #823				
Layer / Reduced Level	2	2	2				
Thickness of Layer (mm)	300	300	300				
Soil Description	Sandy CLAY with gravel, pale brown/orange, L-M Pl	Sandy CLAY with gravel, pale brown/orange, L-M Pl	Sandy CLAY with gravel, pale brown/orange, L-M Pl				
Test Depth (mm)	275	275	275				
Sieve used to determine oversize (mm)	19.0	19.0	19.0				
Percentage of Wet Oversize (%)	0	0	0				
Field Wet Density (FWD) t/m ³	1.96	1.95	1.95				
Field Moisture Content %	11.3	12.5	9.8				
Field Dry Density (FDD) t/m ³	1.76	1.73	1.77				
Peak Converted Wet Density t/m ³	1.94	1.98	1.95				
Adjusted Peak Converted Wet Density t/m ³	**	**	**				
Moisture Variation (Wv) %	2.5	2.0	3.0				
Adjusted Moisture Variation %	**	**	**

Hilf Density Ratio (%)	101.5	98.5	99.5				
Compaction Method	Standard	Standard	Standard				
Report Remarks	**	**	**

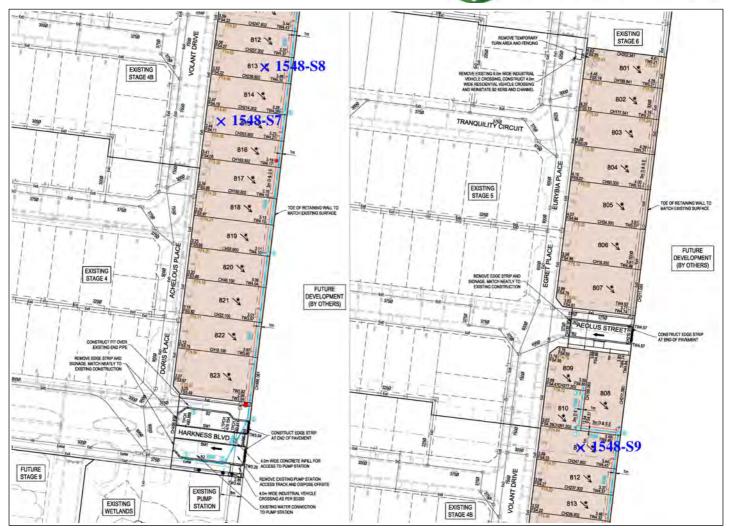
Report Number: GSSW1548-3

Compaction Control AS 1289 5.7.1 & 5.8	.1 & 2.1.1		
Sample Number	1548-S7	1548-S8	1548-S9
Date Tested	27/06/2022	27/06/2022	27/06/2022
Time Tested	15:20	15:40	16:00
Test Request #/Location	Lot #815	Lot #813	Lot #811
Layer / Reduced Level	2	2	2
Thickness of Layer (mm)	300	300	300
Soil Description	Sandy CLAY trace gravel, pale brown/orange, L-M PI	Sandy CLAY trace gravel, pale brown/orange, L-M PI	Sandy CLAY trace gravel, pale brown/orange, L-M PI
Test Depth (mm)	275	275	275
Sieve used to determine oversize (mm)	19.0	19.0	19.0
Percentage of Wet Oversize (%)	0	0	0
Field Wet Density (FWD) t/m ³	2.00	1.84	2.00
Field Moisture Content %	12.5	12.5	13.3
Field Dry Density (FDD) t/m ³	1.78	1.64	1.76
Peak Converted Wet Density t/m ³	1.90	1.88	1.97
Adjusted Peak Converted Wet Density t/m ³	**	**	**
Moisture Variation (Wv) %	3.0	2.5	3.0
Adjusted Moisture Variation %	**	**	**
Hilf Density Ratio (%)	105.0	98.0	101.0
Compaction Method	Standard	Standard	Standard

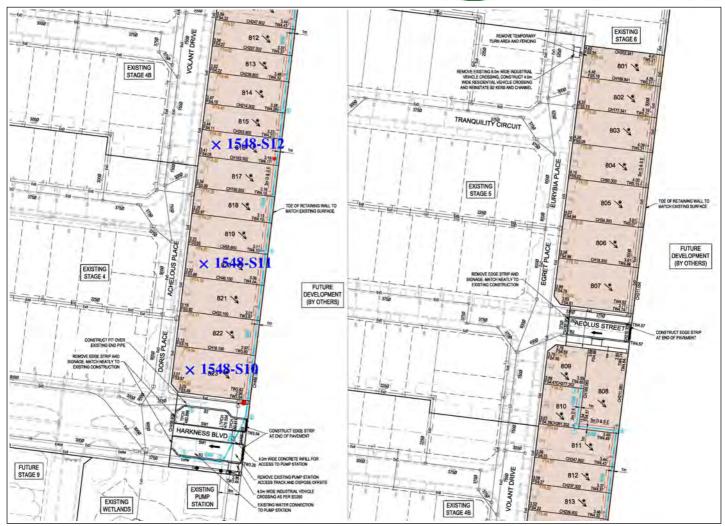
Report Number: GSSW1548-4

Compaction Control AS 1289 5.7.1 & 5.8	3.1 & 2.1.1			
Sample Number	1548-S10	1548-S11	1548-S12	
Date Tested	28/06/2022	28/06/2022	28/06/2022	
Time Tested	14:51	15:01	15:17	
Test Request #/Location	Lot #823	Lot #820	Lot #816	
Layer / Reduced Level	3	3	3	
Thickness of Layer (mm)	300	300	300	
Soil Description	Sandy CLAY with gravel, trace silt, pale brown/orange, low to medium plastisity, dry to moist	Sandy CLAY with gravel, trace silt, pale brown/orange, low to medium plastisity, dry to moist	Sandy CLAY with gravel, trace silt, pale brown/orange, low to medium plastisity, dry to moist	
Test Depth (mm)	275	275	275	
Sieve used to determine oversize (mm)	19.0	19.0	19.0	
Percentage of Wet Oversize (%)	**	0	0	
Field Wet Density (FWD) t/m ³	1.94	1.88	1.94	
Field Moisture Content %	13.2	16.6	17.5	
Field Dry Density (FDD) t/m ³	1.72	1.61	1.65	
Peak Converted Wet Density t/m ³	2.00	1.95	2.05	
Adjusted Peak Converted Wet Density t/m ³	**	**	**

Moisture Variation (Wv) %	3.0	2.5	2.0	
Adjusted Moisture Variation %	**	**	**	
Hilf Density Ratio (%)	97.0	96.0	95.0	
Compaction Method	Standard	Standard	Standard	
Report Remarks	**	**	**

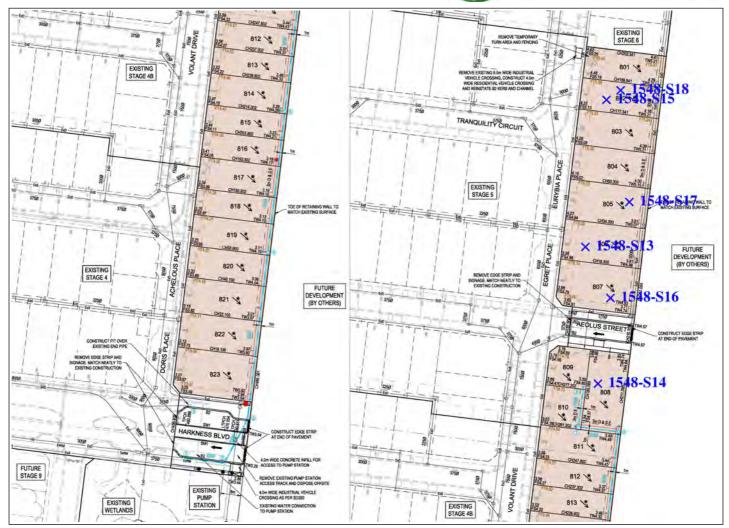
Report Number: GSSW1548-5

Compaction Control AS 1289 5.7.1 & 5.8.1 & 2.1.1						
Sample Number	1548-S13	1548-S14	1548-S15	1548-S16	1548-S17	1548-S18
Date Tested	20/07/2022	20/07/2022	20/07/2022	20/07/2022	20/07/2022	20/07/2022
Time Tested	10:03	10:16	10:28	13:44	13:52	13:59
Test Request #/Location	Lot #806	Lot #808	Lot #802	Lot #807	Lot #805	Lot #802
Layer / Reduced Level	1	1	1	2	2	2
Thickness of Layer (mm)	300	300	300	300	300	300
Soil Description	Sandy CLAY with gravel, pale brown/orange, low - medium plasticity.					
Test Depth (mm)	275	275	275	275	275	275
Sieve used to determine oversize (mm)	19.0	19.0	19.0	19.0	19.0	19.0
Percentage of Wet Oversize (%)	0	0	0	9	0	5
Field Wet Density (FWD) t/m ³	2.00	1.88	2.02	2.01	1.97	2.07
Field Moisture Content %	19.6	25.1	18.3	13.0	15.2	14.3
Field Dry Density (FDD) t/m ³	1.68	1.50	1.70	1.78	1.71	1.81
Peak Converted Wet Density t/m ³	2.00	1.94	1.89	**	1.95	**
Adjusted Peak Converted Wet Density t/m ³	**	**	**	1.99	**	1.98

Moisture Variation (Wv) %	0.0	-0.5	2.0	**	2.5	**
Adjusted Moisture Variation %	**	**	**	2.0	**	2.0
Hilf Density Ratio (%)	100.5	97.0	106.5	101.0	100.5	105.0
Compaction Method	Standard	Standard	Standard	Standard	Standard	Standard
Report Remarks	**	**	**	**	**	**

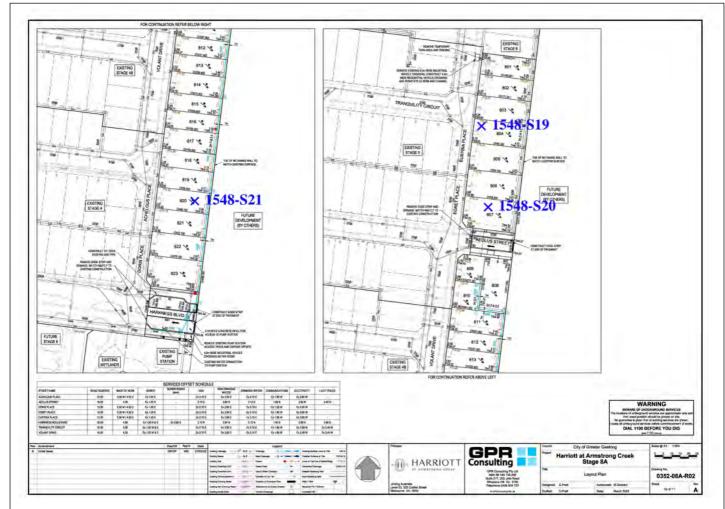
Report Number: GSSW1548-6

Compaction Control AS 1289 5.7.1 & 5.8	.1 & 2.1.1			
Sample Number	1548-S19	1548-S20	1548-S21	
Date Tested	22/07/2022	22/07/2022	22/07/2022	
Time Tested	14:59	15:13	15:28	
Test Request #/Location	Lot #804	Lot #807	Lot #820	
Layer / Reduced Level	3	3	3	
Thickness of Layer (mm)	300	300	300	
Soil Description	Sandy CLAY with gravel, pale brown/orange, low - medium plasticity.	low - medium brown/orange, low - medium brown		
Test Depth (mm)	275	275	275	
Sieve used to determine oversize (mm)	19.0	19.0	19.0	
Percentage of Wet Oversize (%)	0	0	0	
Field Wet Density (FWD) t/m ³	1.89	2.01	2.12	
Field Moisture Content %	21.3	19.3	19.1	
Field Dry Density (FDD) t/m ³	1.56	1.69	1.78	
Peak Converted Wet Density t/m ³	1.98	2.06	2.01	
Adjusted Peak Converted Wet Density t/m ³	**	**	**	
Moisture Variation (Wv) %	0.0	0.0	0.5	
Adjusted Moisture Variation %	**	**	**	
Hilf Density Ratio (%)	95.5	98.0	105.5	
Compaction Method	Standard	Standard	Standard
